#### Retiming camshaft—after refitting cylinder head

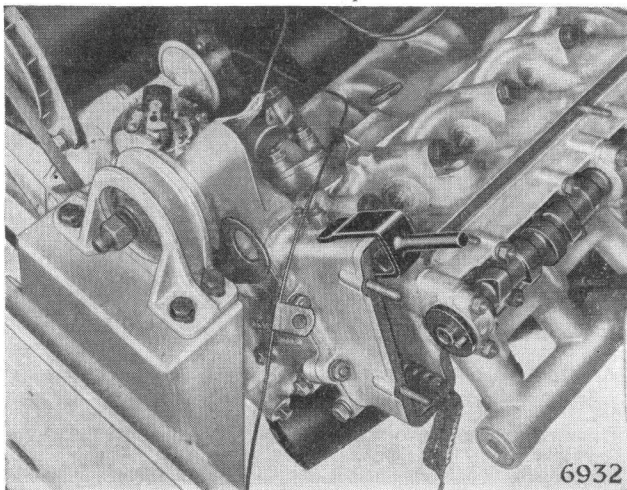
**Fig. 40.** Camshaft position when engine is at No. 1 TDC firing—and timing chain tensioner compressing tool in position

Refit the camshaft so that No. 1 cylinder cam peaks are the same height from the cylinder head cover face. In this position No. 7 and 8 cams are holding No. 4 cylinder valves open slightly. See Fig. 40.

Place Churchill timing chain tensioner compressor RG354 in position. See Figs. 28 and 40. This tool allows easier replacement of the camshaft sprocket.

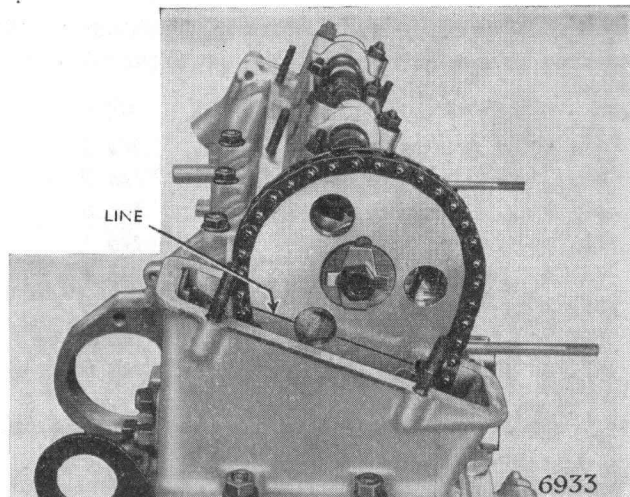
**Fig. 41.** Camshaft sprocket marking line position for No. 1 TDC firing position

Place the camshaft sprocket in the timing chain so that the line on the sprocket is parallel to the timing cover top edge. This will allow the camshaft sprocket to be placed onto the camshaft flange dowel. See Fig. 41.

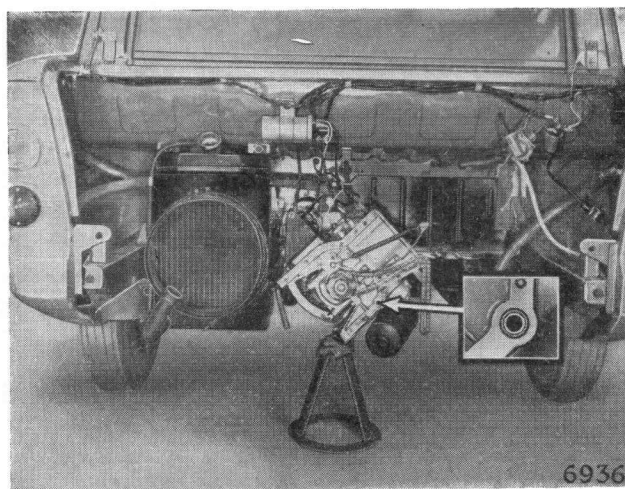
**Fig. 42.** Timing cover removed showing oil passage rubber sealing ring in position
